## Localization techniques

### Ultrasound Sonography (USS)

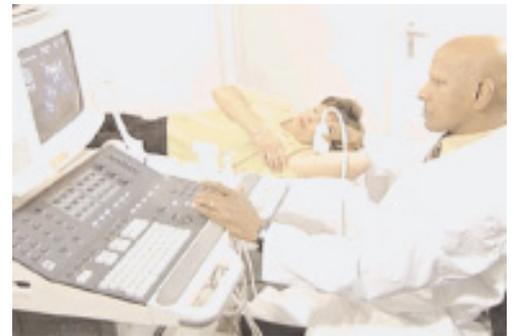
**Figure 1**  
Locating an Nexplanon rod with Philips HDI 5000 ultrasound equipment.

The HDI ultrasound systems of Philips Medical Systems, in particular the HDI 5000, are well suited for the identification of corpora aliena like the implant (Fig. 1). Philips Medical Systems incorporates the so-called Sono Compound Technique (SonoCT) in its ultrasound systems. This technique produces one compound image of nine different images from nine different angles, compared with a single line of sight with conventional ultrasound. As can be seen in figures 2A and 2B, the SonoCT produces a distinctive acoustic shadow. Many details of the implant and the surrounding tissue can be visualized. The different beams may also be helpful in the exact positioning of the actual implant, but they are not essential.

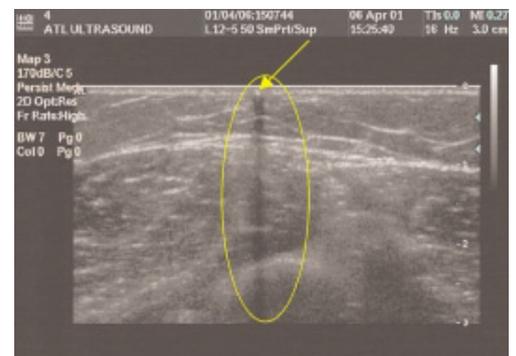
**Figure 2a**  
Acoustic shadow of Nexplanon using SonoCT Compound technique. Please note that the acoustic shadows indicate the exact position of the implant, which is visible as an echogenic spot.

Nexplanon can be identified and located by its **acoustic shadow** (see figures 2a and 2b). The ultrasound image of the implant is very distinctive and is unlikely to be overlooked in the surrounding tissue.

The acoustic shadow will enable you to identify the exact position of the implant itself, which will be visible as a small but clear echogenic spot (see figures 2a and 2b).

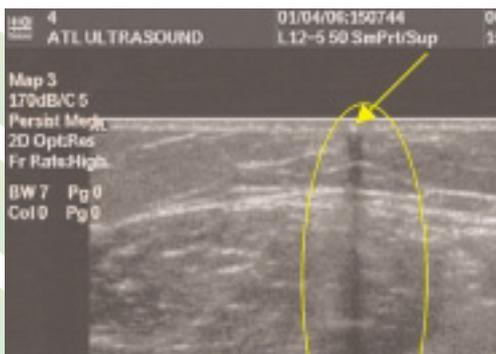
**Figure 3**

Transversal ultrasound image without SonoCT of a correctly inserted implant using a 12-5 MHz transducer. Please note the superficial position of the implant, indicated by the arrow and the clear acoustic shadow indicated by the circle.

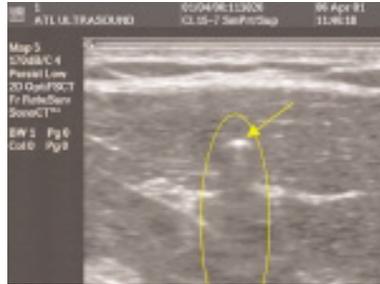
**Figure 4**  
Transversal ultrasound image of an implant inserted in the m. biceps, using a 15-7 MHz transducer. Please note that the arrow indicates the actual implant and the circle indicates the acoustic shadow.

Because Nexplanon has a cross-sectional diameter of only 2 mm, high resolution is important for ultrasound visualization. As can be seen in figures 4 to 13, Nexplanon can be visualized with all US transducers, high, intermediate and low frequency. However, the best results are obtained with high frequency transducers including a high frequency linear array transducer (12-5 MHz) and a very high frequency linear array transducer (15-7 MHz). When using a low or intermediate frequency transducer, application of a silicone patch or a large amount of gel enhances visibility of the implant.

The ultrasound images numbered 4 to 13 show an implant inserted in the musculus biceps. With this series of images of the same patient we would like to show that Nexplanon can be localized with low, intermediate and high frequency transducers. As can be seen in figures 4 to 13 the best results are obtained with the high frequency transducers.

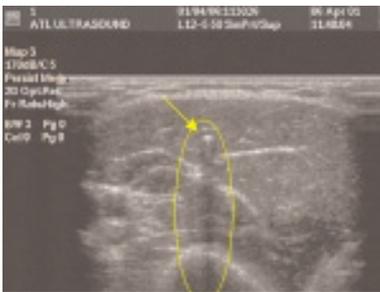
**Figure 6**  
Transversal ultrasound image of an implant inserted in the m. biceps, using a 12-5 MHz transducer. The arrow indicates the actual implant and the circle indicates the acoustic shadow.

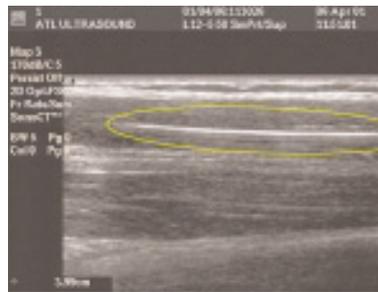
**Figure 7**  
Longitudinal ultrasound image of the full length of an implant inserted in the m. biceps, using a 12-5 MHz transducer. The circle indicates the actual implant.

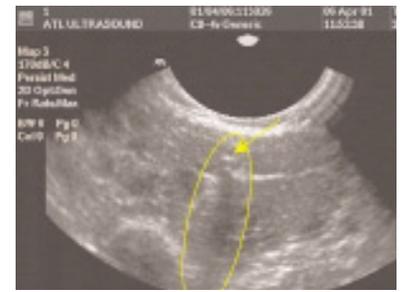
**Figure 8**  
Transversal ultrasound image of an implant inserted in the m. biceps, using an 8-4 MHz vaginal transducer. The arrow indicates the actual implant and the circle indicates the acoustic shadow.

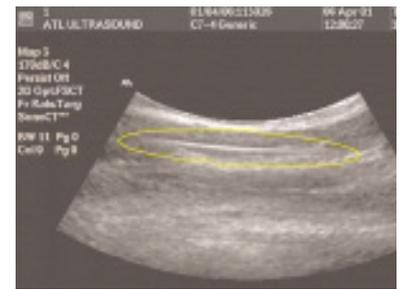
**Figure 11**  
Longitudinal ultrasound image of the full length of an implant inserted in the m. biceps, using a 7-4 MHz transducer. The circle indicates the position of the actual implant.

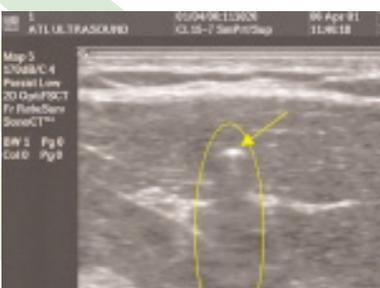
**Figure 12**  
Transversal ultrasound image of an implant inserted in the m. biceps, using a 5-2 MHz transducer. The arrow indicates the actual implant and the circle indicates its acoustic shadow.

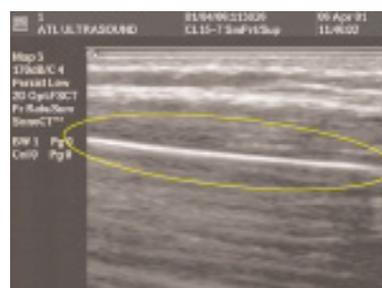
**Figure 13**  
Longitudinal ultrasound image of the full length of an implant inserted in the m. biceps, using a 5-2 MHz transducer. The circle indicates the position of the actual implant.

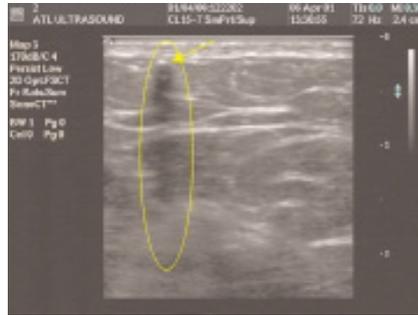
**Figure 14**

Transversal ultrasound image of the distal tip of an implant inserted with the “injection” technique, using a 15-7 MHz transducer. The arrow indicates the actual implant and the circle indicates its acoustic shadow.

The ultrasound images of figures 14 and 15 show an implant that was difficult to palpate. It was found that the proximal tip was localized deeper than the distal tip, moreover the implant was slightly curled indicating the use of an incorrect “injection” technique. Since the implant was curled it was not possible to obtain a proper longitudinal view of the implant.

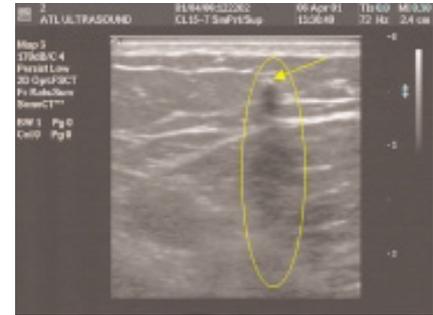
**Figure 15**

Transversal ultrasound image of the proximal tip of an implant inserted with the “injection” technique, using a 15-7 MHz transducer. The arrow indicates the actual implant and the circle indicates its acoustic shadow.

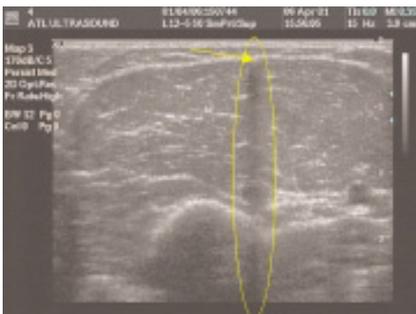
**Figure 16**

Transversal ultrasound image of an implant inserted just underneath the fascia brachii of the musculus biceps using a 12-5 MHz transducer. The arrow indicates the actual implant and the circle indicates the acoustic shadow.

The ultrasound images of figures 16 to 18 show an implant that was inserted erroneously on top of the upper arm instead of the inner side. The layer of connective tissue is much thinner at this place and combined with an incorrectly performed insertion technique this resulted in an implant inserted just underneath the fascia brachii of the musculus biceps, which made it impossible to palpate.

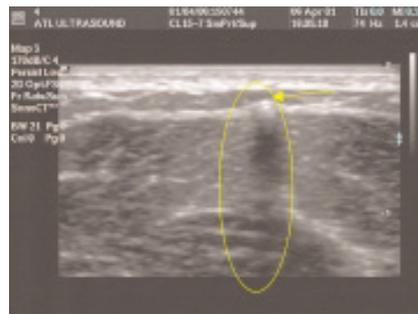
**Figure 17**

Subfascial detailed ultrasound image of the subfascial position of an implant using a 15-7 MHz transducer. The arrow indicates the actual implant and the circle indicates the acoustic shadow.

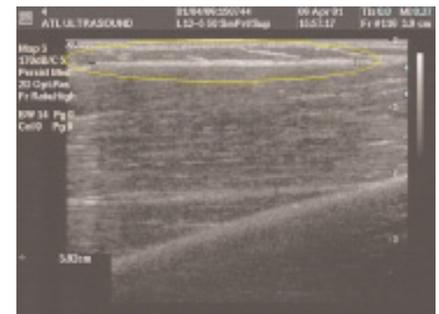
**Figure 18**

Longitudinal ultrasound image of the full length of an implant inserted just underneath the fascia brachii of the musculus biceps using a 12-5 MHz transducer.
